Executive Summary

TRMM Flight Operations Team Systems Engineers

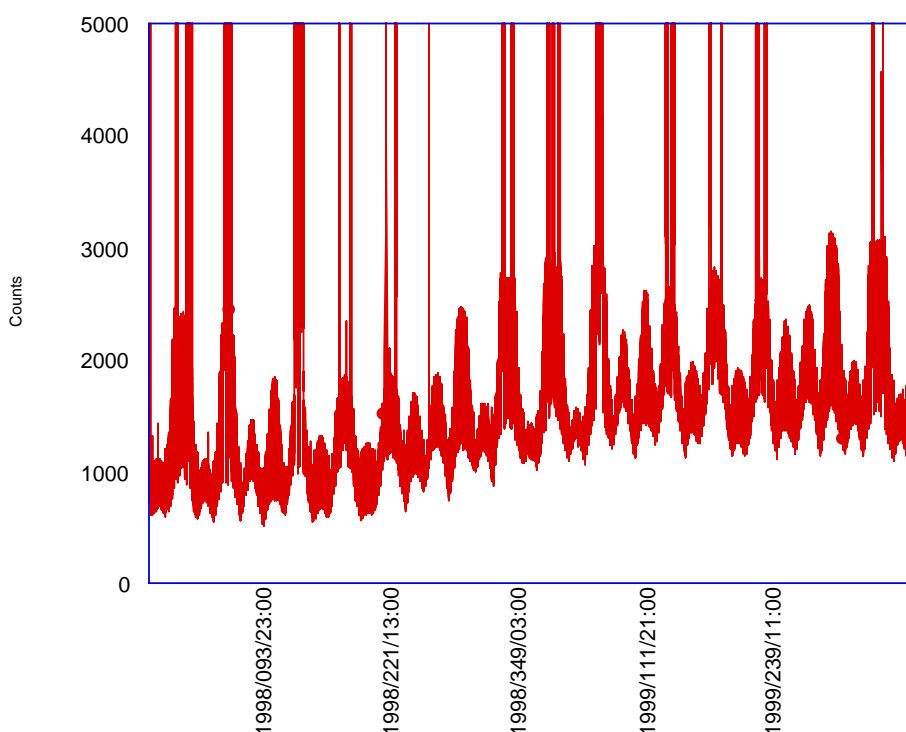
Figure 4.1-2 S-Counts for ESA Quadrant 1

The ESA has exhibited anomalous fogging behavior over the past 9 months. The S-counts in quadrant 1 have drifted above the expected plateau observed since Launch. It appears that this behavior began around the time of the Deep Space Calibration in September of 1998 and has steadied at approximately 1300 counts (600 originally - see Figure 4.1-2). Since this is well below the concern threshold of 2500 counts, and no other quadrant has displayed such a distinct trend in any counts, the manufacturer is not concerned with the performance of the sensor. If the drift becomes too great, or begins to cause problems in attitude control, then a bias will be loaded to reduce the overall effect.

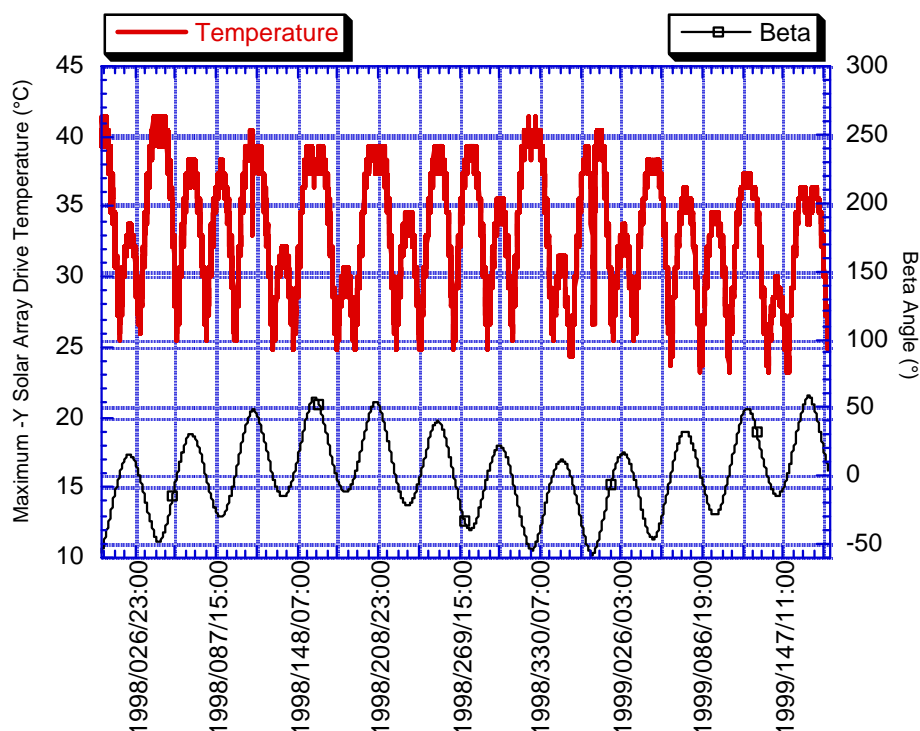
Figure 4.2-1 -Y Solar Array Drive Temperature and Beta Angle

The slewing of the solar arrays continue to be nominal during eclipse transition and maneuver operations, although there is one area of concern. The -Y solar array actuator temperature has peaked several times at approximately 41.5 °C (Figure 4.2-1), just below the Yellow High (YH) temperature of 42 °C, during the Beta angle of 48° (when the Sun has the best view of the shoulder hinge and the output flange of the Solar Array Drive Assemblies (SADAs)). This trend is a long-term concern because the actuator Penzane lubricant could degrade and evaporate if the bearing temperatures, which cannot be measured directly, are higher than expected. The life test temperature of the solar array drive motor is 37 °C. Thermal analysis predicts that for these exterior temperatures, the ball bearing interior temperatures within the actuator may be as high as 73 °C. Even a 10 °C increase in temperature is 100 times more likely to evaporate the lubricant and potentially cause undetected levels of metal particles, which could be magnetically attracted to the gears in the zero-gravity environment. Due to the nature of the telemetry downlinked and stepper motors, there will probably be no indication until a motor failure occurs and causes the spacecraft to transition into Sun Acquisition mode. Several measures have been considered because of the possibility of a potential solar array drive failure.

In order to reduce the array duty cycle, the FSW group was asked to implement a solar array limiting scenario, in which the arrays would only be allowed to track between $\pm 50^\circ$ (originally $\pm 130^\circ$). The feather position for both arrays would remain at 0° . After successful tests with the simulator, this plan was implemented on the spacecraft on 98-146 by loading ACS Table #76 (Solar Array Parameters). Unfortunately, during the first orbit in daylight, as the solar arrays reached the software stops during normal sun tracking, it was noticed that the ACS still sent rate commands to the SA drive motors. After reviewing the flight code, it was determined that during the time the arrays are limited, the ACS software computes the commanded velocity for the solar arrays before it limits the commanded position based on the software stops. As a result, the ACS commanded velocity is high, even though the actual velocity is zero, since the arrays are already at the software stop. The solar array drives were actually drawing slightly more current than they would if they were feathered or stopped, even though they were not actually moving. Since possible effects could not be confirmed through telemetry, it was unknown if the arrays were 'jiggling'. This would actually be worse for the array drive than the higher temperature condition it is experiencing. Solar array dithering was never experienced with the old stops of $\pm 130^\circ$ because the arrays never reached the software stops at any Beta angle. On 98-147, the original software stops were restored, and the FSW group was tasked with developing a software patch that would eliminate any possibility of this dithering effect.

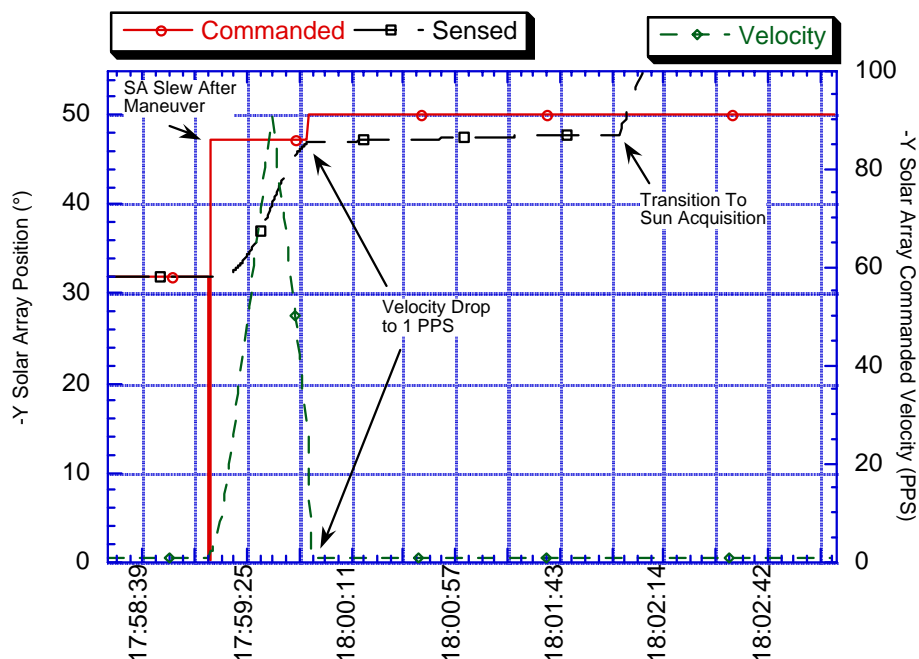
Figure 4.2-2 Anomaly #71: -Y Solar Array Position and Velocity

Upon determining the anomaly was the result of the way that the ACS flight code was written, and not a solar array drive or GSACE failure, it was decided to switch back to GSACE A on 99-004. Before transitioning back to Normal mode on the next day, the old solar array software stops of $\pm 130^\circ$ were uplinked until further analysis could be done for the new stops.

After performing tests with worst-case scenarios, where the commanded versus sensed position would be the greatest, it was determined that 12° would be a good tolerance for use by FDCs #112 and 113. On 99-040, the new tolerance and the $\pm 50^\circ$ software stops were uplinked in ACS System Table #76. However, this new FDC limit would only indicate a GSACE failure, but would not provide a warning if a solar array drive was slipping. This was important because the +Y and -Y solar array glitch buffer was no longer being updated since the arrays were no longer passing through 90° . Therefore ACS TSMs (#2-13) were created to perform the same task as the old FDCs. The TSMs would trip if they registered a difference of 0.51° , 5° , and 10° between the sensed and commanded position for two minutes. The action taken would be an event message. TSM #4 and 7 would be reset at the end of each day's spacecraft ATS load to ensure the TSM maximum message count would not be exceeded. Since the implementation on 99-047, these TSMs have tripped twice following Delta-V maneuvers.

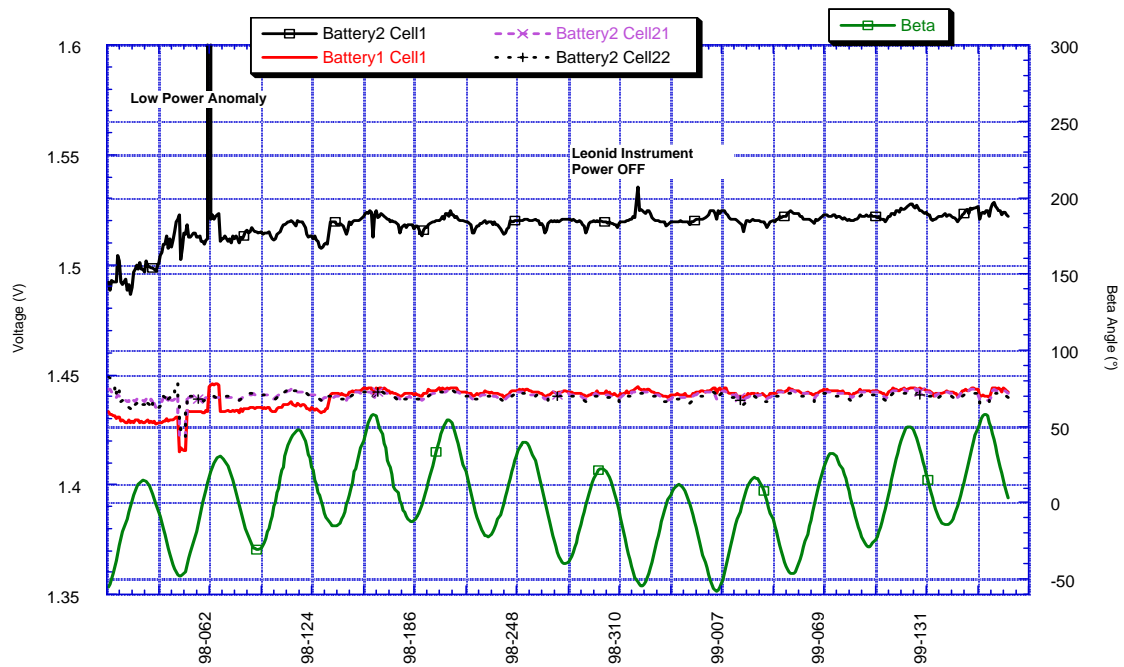
Figure 4.4-2 Battery Cell Voltage Maximums

On 98-028, Battery-2 Cell-1 voltage began hitting the YH limit (Anomaly #55) of 1.49 volts. The cell charges 'in family', along with other nearby cells, until it approaches the V/T limit. As the V/T limit is approached, the cell diverges sharply upward and reaches its peak in conjunction with the V/T limit. Once the limit has been reached, the cell returns to the charge cycle 'in family'. See Figure 4.4-1 for a typical orbit profile of Battery-2 Cell-1 when compared to other battery cells and Figure 4.4-2 for the trend of daily maximum cell voltages.

On 98-043 at 13:59, with direction from Code 563, the V/T level was changed to 4 and the C/D was lowered to 1.03 to maintain a 100% SOC counter at the lower V/T level. All changes made during the report period for the anomaly are shown in Table 4.4-1. Lowering the V/T level was thought to clamp the maximum peak on Battery-2 Cell-1. These changes did not affect the peak, it remained at approximately 1.52 volts. Then, on 98-043/17:09, the auto-SPRU step-to-charge level was changed to a Constant Current (CC) of 48 amps (or 24 amps per battery) with a gain setting of 1. This did not affect the Battery-2 Cell-1 peak either, but did affect the ability of Battery-1 to reach 100% SOC. On 98-049 at 14:50, the V/T level was returned to 5, in order to maintain energy balance, and the step-to-charge setting was lowered to 24 amps (or 12 amps per battery) with a gain setting of 1. The charge current was chosen to lower the initial energy hit to the batteries that seems to aggravate the anomalous Battery-2 Cell-1.

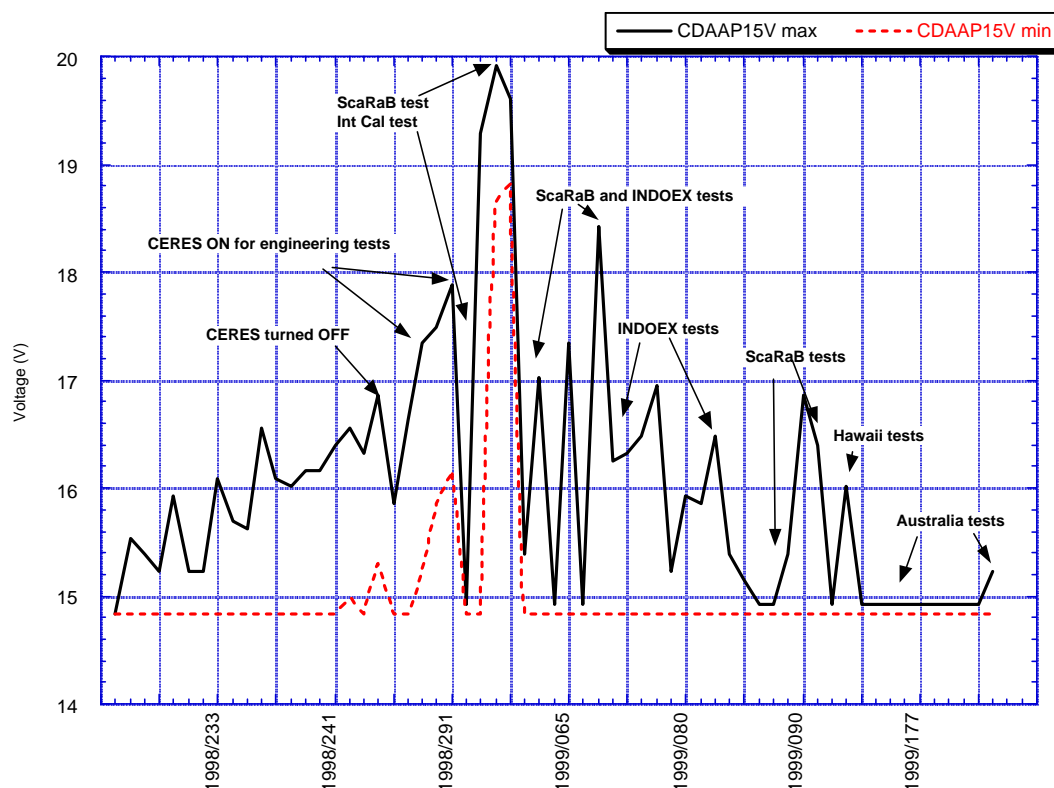
Figure 5.1-1 CERES DAA +15 V Converter Daily Voltage

The DAA +15V voltage converter began reaching the YH limit of 15.75 volts on 98-230 (Anomaly #69). Trending revealed that the converter began anomalous behavior of unregulation on 98-212. See Figure 5.1-1 for the daily maximum and minimum voltage of the converter. The converter began with nominal regulation on Crosstrack operational days, while hitting YH limits during Biaxial and Along-track operational days. Also a diurnal temperature effect was seen during the middle of the GMT day that coincided with the daily maximum voltage. On 98-237, CERES was placed in Crosstrack mode only to reduce the motor bearing temperature and converter voltage. On 98-244, the instrument was powered off at LaRC's instructions, when the converter reached a high value of 16.5 volts.

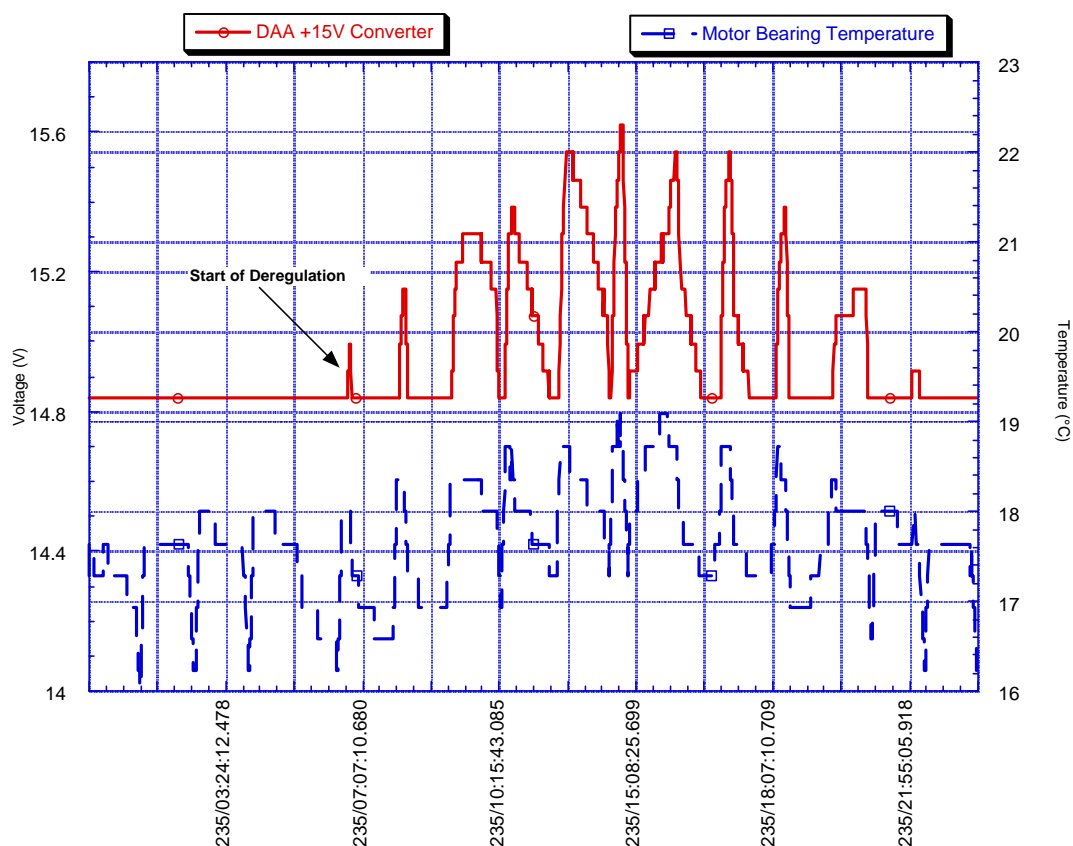
Figure 5.1-2 +15 V DAA Converter and Motor Bearing Temperature

exceeded 18.0 volts. On 98-291 at 09:56, TSMs #35 - 37 exceeded limits and RTS #34 executed and powered off the instrument. Along with the engineering test, a life test was started at Langley to determine the operability of the electronics that are supplied by the anomalous converter. The electronic components were tested with 30 volts supply without any degradation in performance to date.

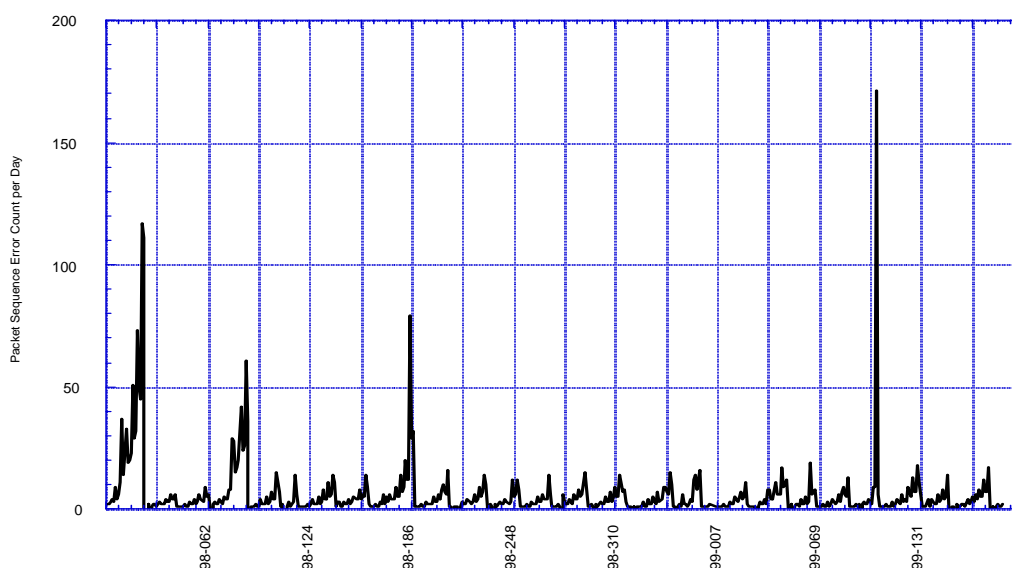
Figure 5.2-1 Number of LIS Packet Sequence Errors per Day

Since changing to the 8 kbps background mode, LIS has experienced packet sequence errors even though the maximum number of packets are received each day. The instrument occasionally has a science data packet ready before the data bus is ready to receive it (at one second intervals) causing a packet to be missed. Approximately once a month, MSFC requests a sequence of commands to reset the instrument, reconfigure to the 8 kbps background mode, and reload the thresholds (see Figure 5.2-1) to reduce the number of packet sequence errors.
